# POST-INSTALLATION INSPECTION REPORT

Commissioned by : Plan 4 Sport Fitness Trails UK Ltd  
Site Name : Ifield School

01 July 2011

Site Owner : **Plan 4 Sport Fitness Trails UK Ltd**  
Site Name : Ifield School  
Date of Inspection : 01 July 2011  
Inspected by : Mike Langsford

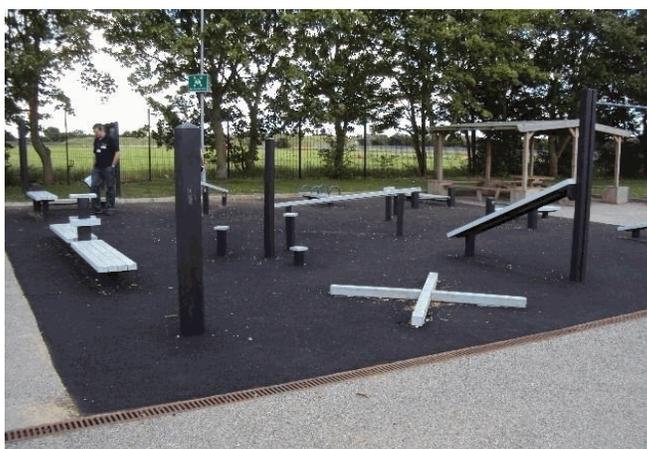
Twelve pieces of agility trail located in rear playground of a special school. Evidence of high supervision of children while in playground and usual school secure access applies.

The agility trail is located on one section of the playground and offers a very good range of fitness activities. It was noted that there were no moving parts to the equipment, The equipment is made of recycled plastic and is of a high standard of construction. The equipment also has pictorial and written instructions on use located at the side of the agility trail.
